## SURFACE TREATMENT OF WELDING WIRES (ER70S6) AND ITS EFFECT ON THE WELDING CHARACTERISTICS

*Bert Breidenbend, Richard Fichtner, Peter Terliesner, GEO Reinigungstechnik GmbH*

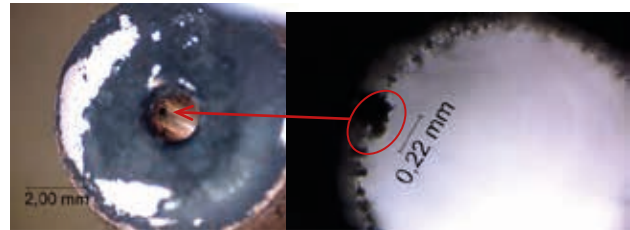
Photo 26: Copper deposits in the contact tip (located about 3 mm deep)

Furthermore the test results give reason to assume that the copper coating does not form an even metallic contact with the wire surface. Possibly the process at the contact area occurs in such a manner that the copper coating melts first at the contact tip and sticks to the wall of the bore in the contact point (copper to copper). Owing to the relative speed of the wire the melted copper does not adhere to the hot zone where the current transfer takes place but in a cold zone in the direction of the wire feed. A metal deposit is formed that briefly increases the friction, noticeable when measuring the wire feed rate and noticeable by the welder in the form of vibrations. The situation is shown in Items 25 and 26.
